# **Phase I Environmental Site Assessment**

**Swap N' Shop  
8327 South Tacoma Way  
Tacoma, WA 98499**

E-10315

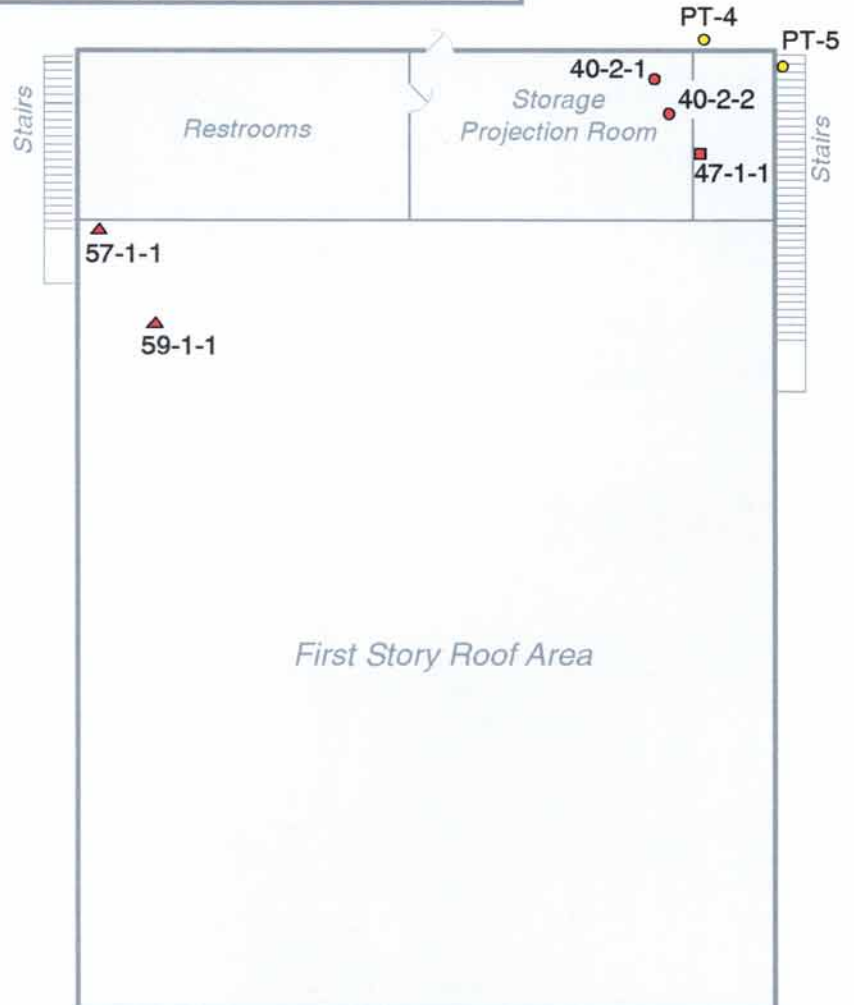
Drwn. GLS	Date Feb. 2003	Proj. No. 10315
Checked RH	Date 2/24/03	Plate 3

The snack bar, restrooms, the projection room and an electrical room occupy building No. 2. We identified five different patterns of vinyl floor tile, linoleum, mastic, cove base, wallboard, popcorn ceiling materials, roofing materials and cement asbestos board.

Black mastic used in the snack bar area was identified by laboratory analysis to have 3 percent to 4 percent chrysotile asbestos. The brown and tan vinyl floor tile sampled in the projection room was identified to contain 3 percent chrysotile asbestos. The cement asbestos board found in the electrical room was identified from laboratory analysis to contain 40 percent chrysotile asbestos. CAB also appears on the outside of building No. 2 as siding materials located on the second level, the projection area. The wallboard sample indicated the surfacing mud contains 2 percent chrysotile asbestos. The black, spread-on tar used as seaming material on the roof over the snack bar contains 5 percent chrysotile asbestos. The black roofing paper sampled on the roof over the projection area has 2 percent chrysotile asbestos. No asbestos was detected in the remaining samples.

Asbestos containing materials were found in building No. 2 and building No. 3. These materials consisted of vinyl floor tiles, mastics, popcorn ceiling materials, linoleum and CAB boards. For demolition purposes both building No. 2 and No. 3 should be considered asbestos materials and handled in the appropriate disposal manner. No asbestos was identified in the remaining samples. Any materials containing more than 1 percent asbestos must be handled and disposed of in accordance with state and federal regulations.
